# FACILITY ASSESSMENT REPORT

316 6th. St.  
Marysville, CA 95901

**Prepared for:**  
Marysville PD  
530-749-3900

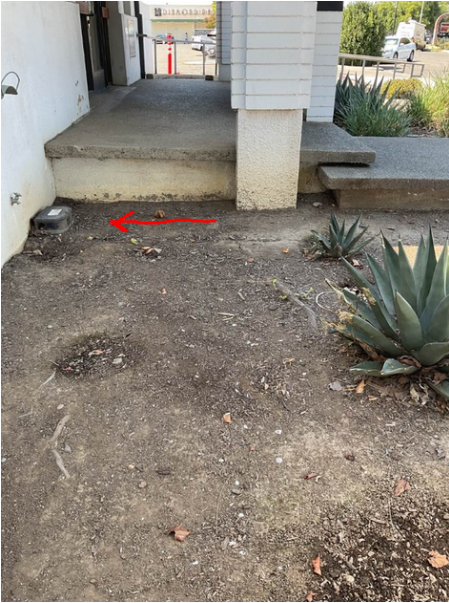
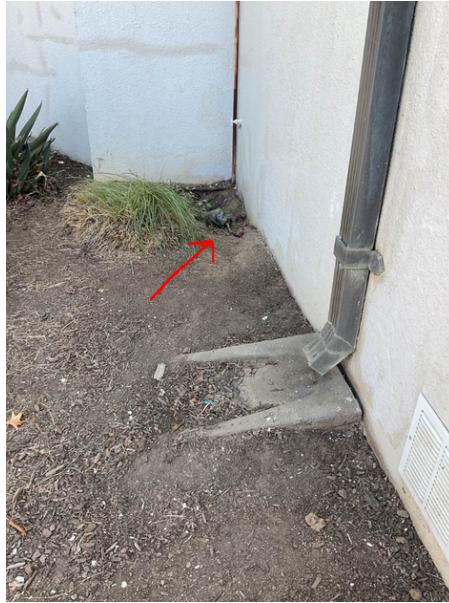
### Lot Grading & Drainage

The North side of the building seems to allow water to back up and hold against the building.

**North side grading:** Improper grading allows water to accumulate against the building's foundation, which can lead to structural damage and moisture intrusion. It is recommended to re-grade the area with a slight slope away from the building to ensure proper drainage. Entrance, sidewalk, and parking area: The large cracks in these paved areas are a trip hazard and can worsen over time due to weather and vehicle traffic. They should be sealed with an appropriate crack filler or, for larger cracks, a professional asphalt or concrete repair service should be consulted to prevent further deterioration.

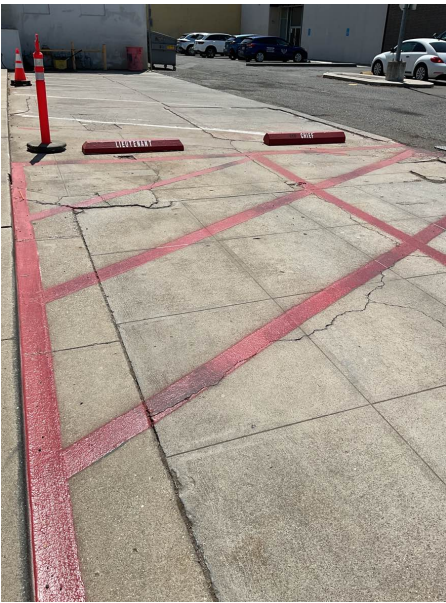
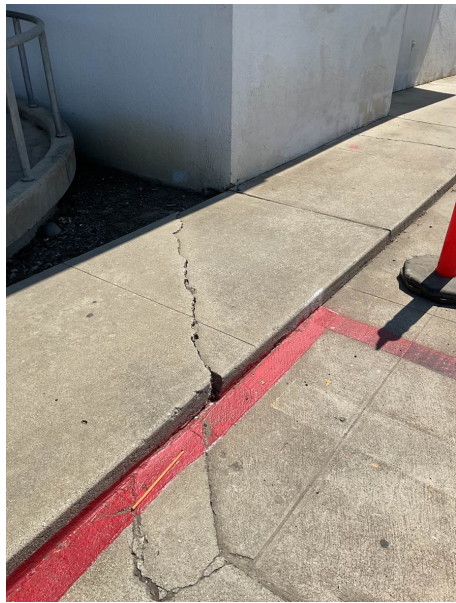
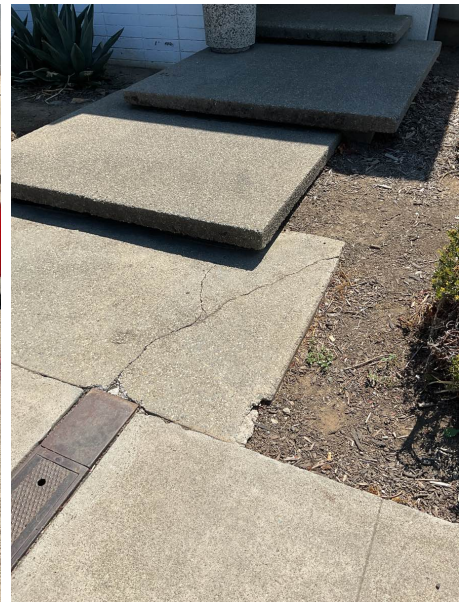
### Driveways / Walkways / Patios

The entrance, sidewalk and private parking area have several large cracks and should be repaired.

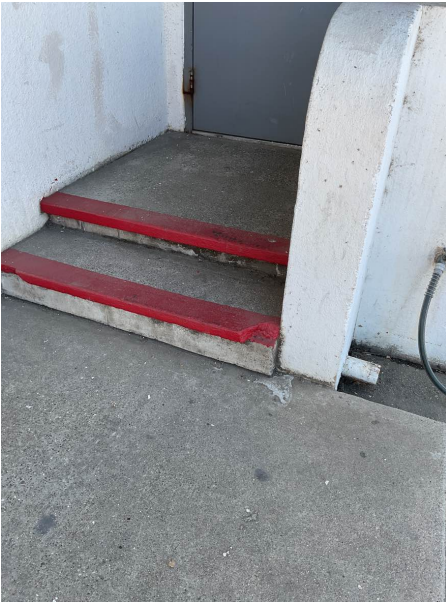
The steps on the west side of building have several areas that are chipped and damaged.

**West side steps:** The chipped and damaged concrete steps are a safety hazard. They should be repaired or replaced to ensure a level and secure surface for foot traffic.

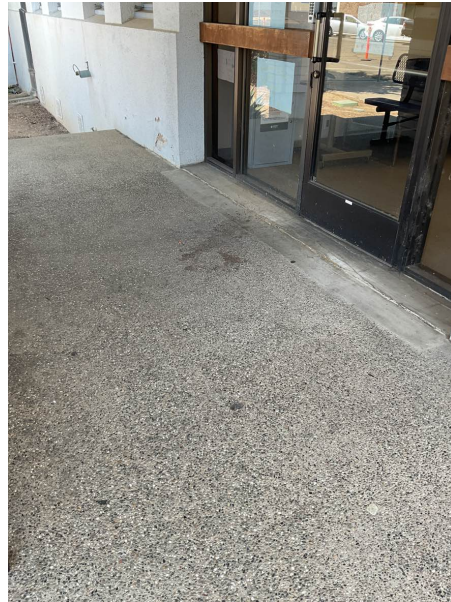
The front entrance has something spilled on it and needs to be pressure washed.

**Front entrance:** The spilled material on the front entrance should be removed with a high-pressure washer. This will improve the property's curb appeal and prevent the material from tracking into the building.

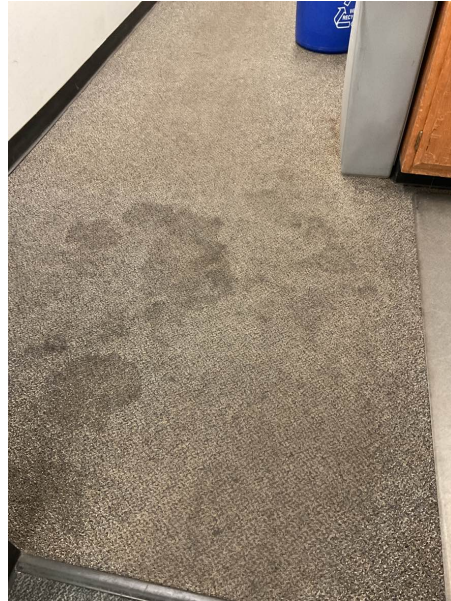
The common area carpet needs to be professionally cleaned or replaced.

**Common area carpet:** The carpet appears to be worn or stained. Professional cleaning may be sufficient to restore its appearance and extend its life. However, if the carpet is extensively worn, replacement is the more durable solution.

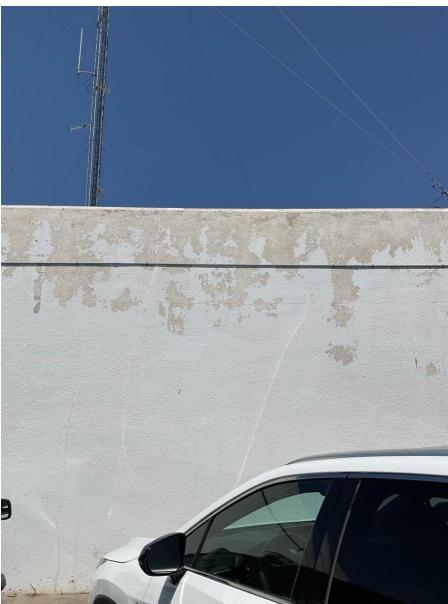
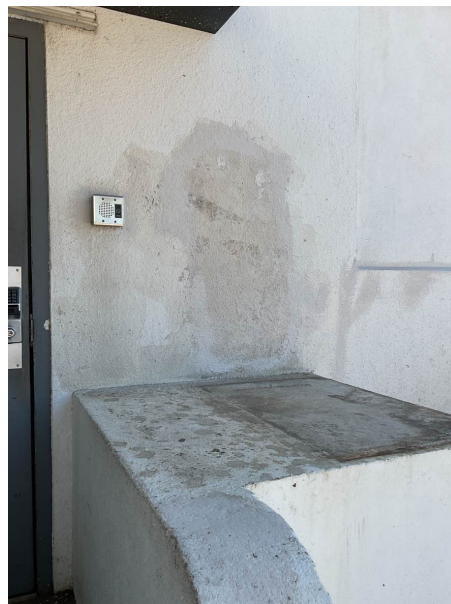
### Exterior Walls

Stucco Walls- Several exterior walls are damaged, and the paint is peeling.

**Exterior walls:** The damaged and peeling paint on the exterior walls not only looks poor but also leaves the underlying material vulnerable to weather damage. The damaged areas should be scraped, patched, primed, and repainted with an exterior-grade paint suitable for the stucco/brick material.

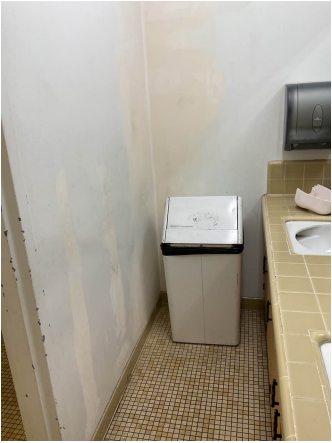
The men's locker room bathroom wall seems to have been repaired but not painted.

**Men's locker room bathroom wall:** The wall has been repaired but not finished. It needs to be primed and painted with a moisture-resistant paint to match the surrounding walls and complete the repair.

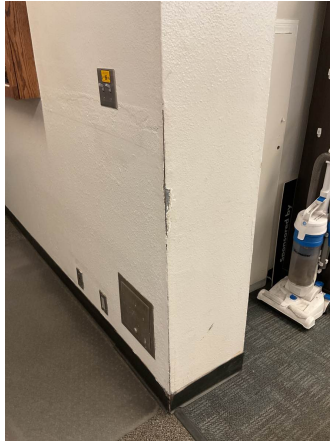
There is damage on wall corners.

**Wall corners:** The damage to the wall corners is likely from routine wear and tear. The damaged drywall or plaster should be repaired and the corners reinforced with corner bead before being repainted.

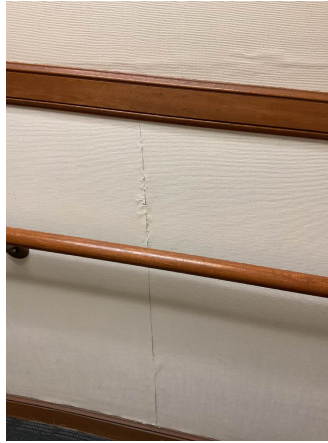
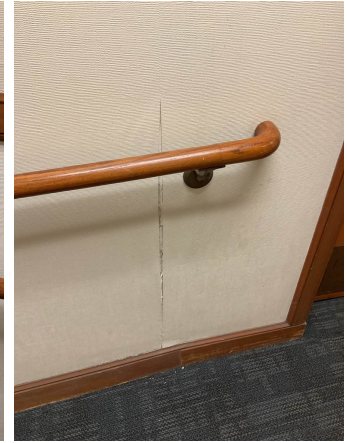
Sheetrock walls with wallpaper- several interior walls in the corridor have wallpaper peeling.

**Interior walls (corridor):** The peeling wallpaper is an aesthetic issue. It should be removed, the walls prepped, and then new wallpaper or a fresh coat of paint applied for a clean, updated look.

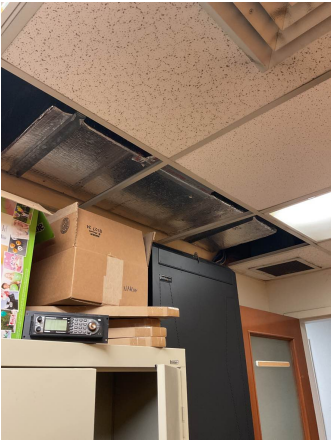
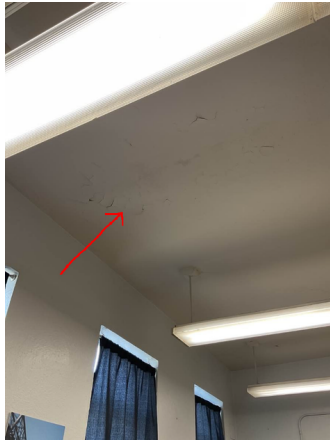
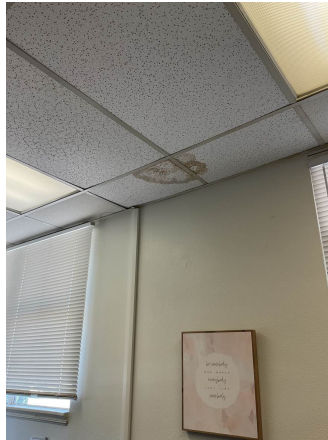
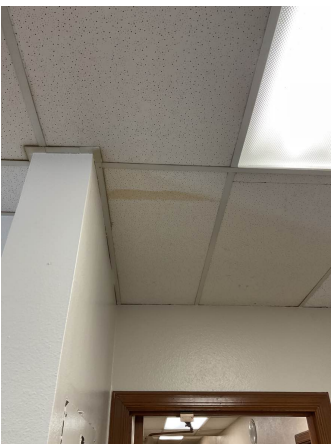
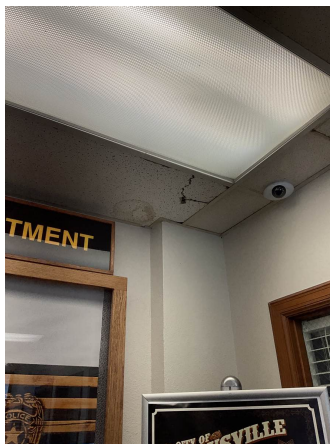
**Ceilings**

Multiple ceiling tiles and hard lid have water damage and should be repaired and replaced.

**Ceiling tiles and hard lid:** The water damage indicates a past or present leak. The source of the leak must be identified and repaired first. Then, the damaged ceiling tiles and hard lid sections should be replaced to prevent mold growth and restore the ceiling's integrity and appearance.

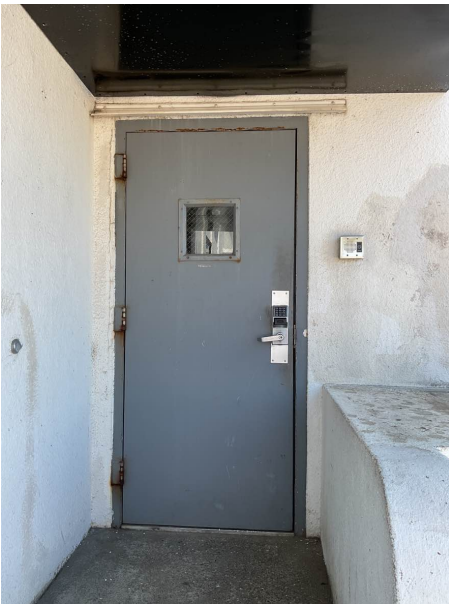
**Doors**

Glass/Metal Doors Several exterior metal doors are rusted and need paint and replacement.

**Exterior metal doors:** The rust on the metal doors indicates they are not properly protected from the elements. The rust should be sanded off, and the doors should be primed with a rust-inhibiting primer and painted with an exterior-grade paint. If the rust is severe, replacement may be a better option.

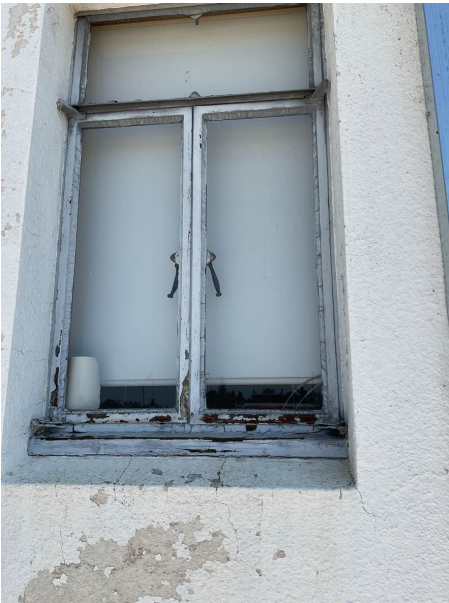
### Windows

Windows are single pane and seem to be allowing moisture inside.

**Single-pane windows:** The presence of moisture suggests a lack of insulation and a potential for drafts. Replacing these windows with modern, double-pane insulated windows will improve energy efficiency and prevent moisture from entering.

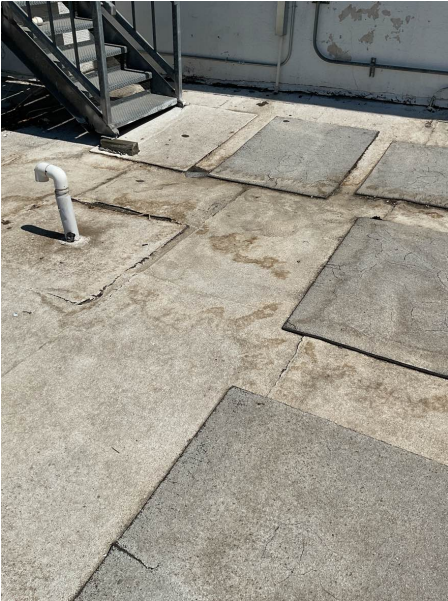
### Roofing Material

The roof is in poor condition and needs to be replaced.

**Roofing and Plumbing Rolled roofing:** The inspector noted the rolled roofing is in poor condition. This type of roofing has a limited lifespan, and its condition indicates it is at or near the end of its service life. It should be replaced by a qualified roofing professional to prevent leaks and protect the building's structure.

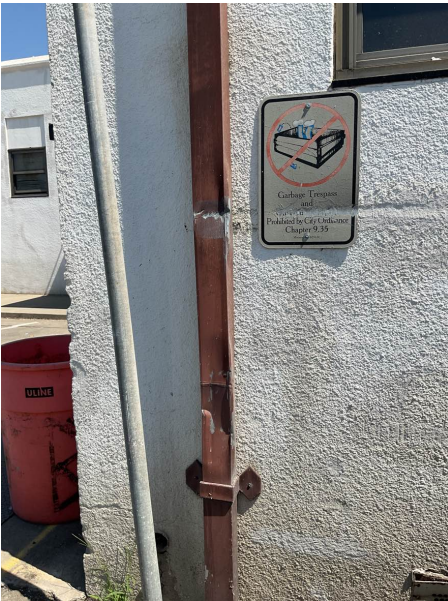
### Gutters & Downspouts

Some of the downspouts are damaged and need to be replaced.

**Downspouts:** Damaged downspouts cannot properly direct water away from the foundation. They should be replaced to ensure effective water management and prevent foundation damage.

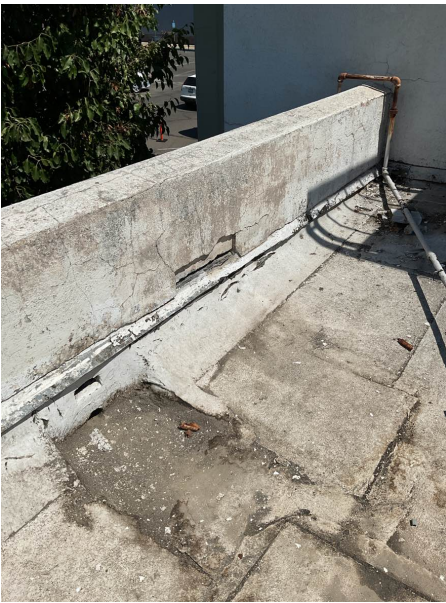
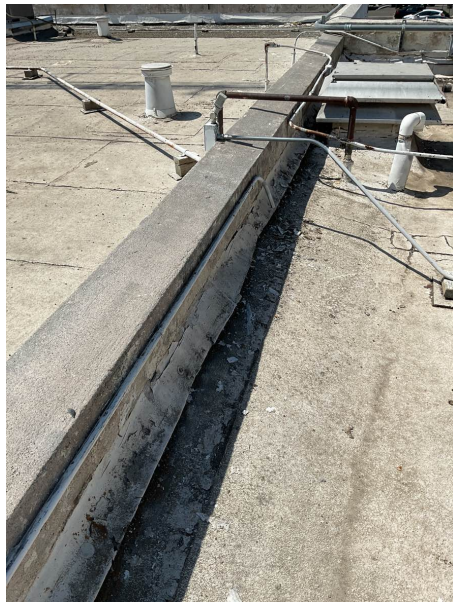
### Flashing

The roof flashings are damaged along parapet wall and need to be replaced.

**Roof flashings:** The damaged flashings are a critical point for water intrusion, especially along the parapet wall. These flashings should be replaced by a roofing professional to maintain a waterproof seal.

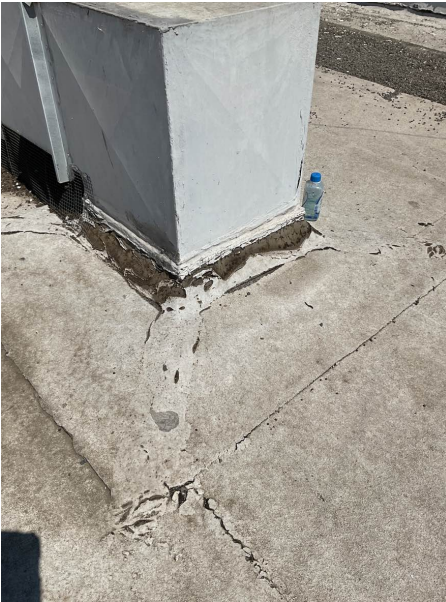
**Skylights / Chimneys / Roof Penetrations**

Several roof penetrations have sealant that are missing and should be replaced to avoid leaking.

**Roof penetrations:** Missing sealant around roof penetrations (such as vents or pipes) is a common cause of roof leaks. The old sealant should be removed, and a new, durable sealant should be applied to create a watertight seal.

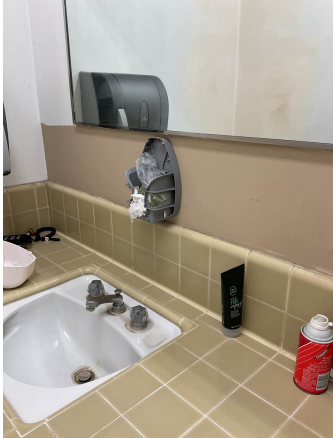
The men's locker room bathroom sinks are old and showing signs of wear. The soap dispenser is damaged and needs to be replaced

**Men's locker room bathroom sinks:** The sinks are old and show wear, which may be a cosmetic or functional issue. They should be replaced to modernize the bathroom and ensure proper function.

**Men's locker room soap dispenser:** The damaged soap dispenser should be replaced with a new one for hygiene and convenience.

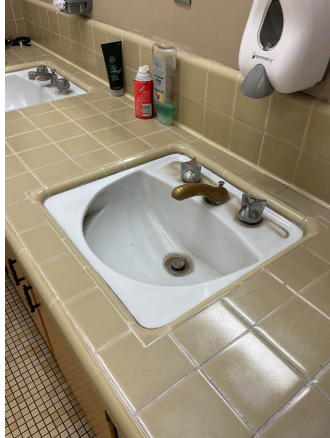
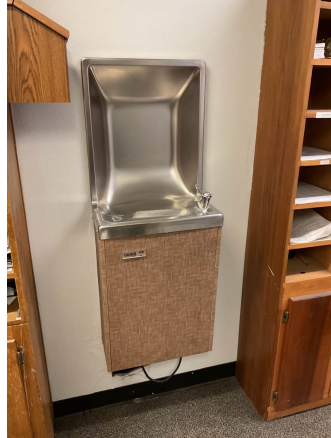
The hall drinking fountain shoots a high stream of water and needs to be replaced or adjusted.

**Hall drinking fountain:** The drinking fountain's high stream of water may be caused by a faulty pressure regulator or a damaged nozzle. A plumber should be called to either adjust the pressure or replace the unit.

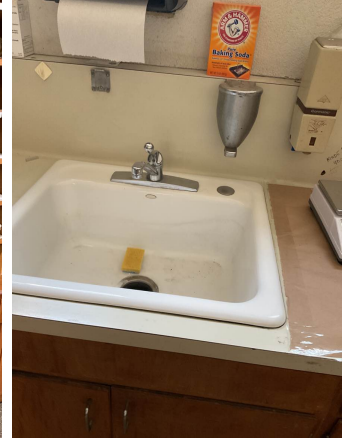
The kitchen sink is operable but shows signs of age, as well as the Formica countertop.

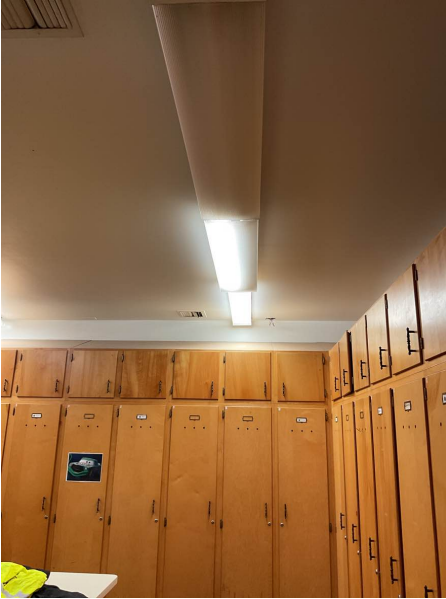
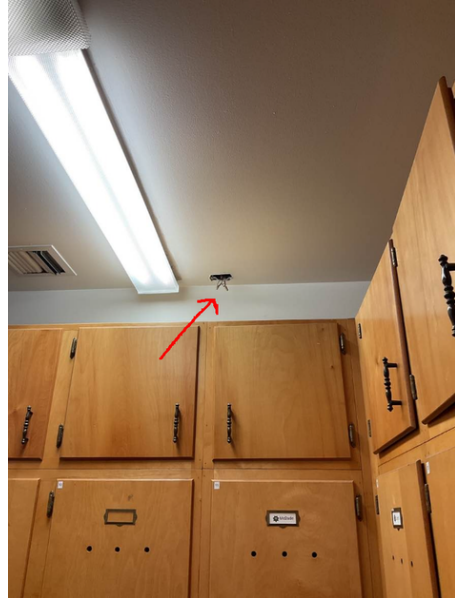
**Fixtures / Switches / Receptacles**

There are exposed wires and several lights out in the Men's locker room. Corridor plug seems to be damaged.

**Damaged plug:** The damaged electrical outlet in the corridor is a safety hazard and a potential fire risk. A qualified electrician should be hired to replace the damaged plug immediately.

**Men's locker room:** The exposed wires and inoperable lights are electrical hazards. An electrician must be called to secure the wiring and replace the burnt-out bulbs or fix the lighting fixtures.

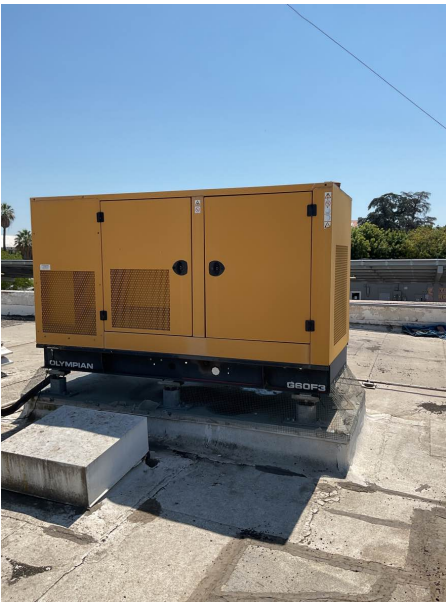
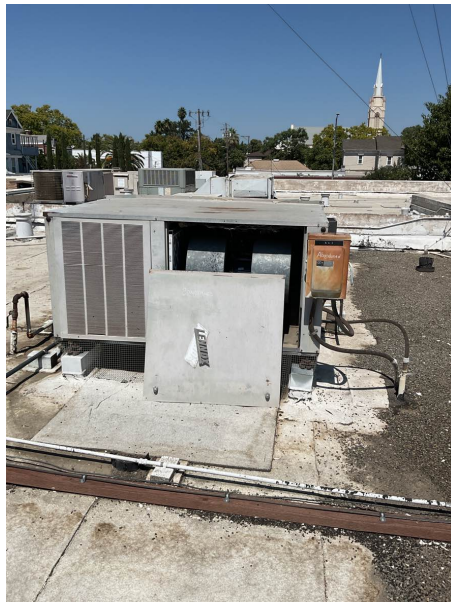
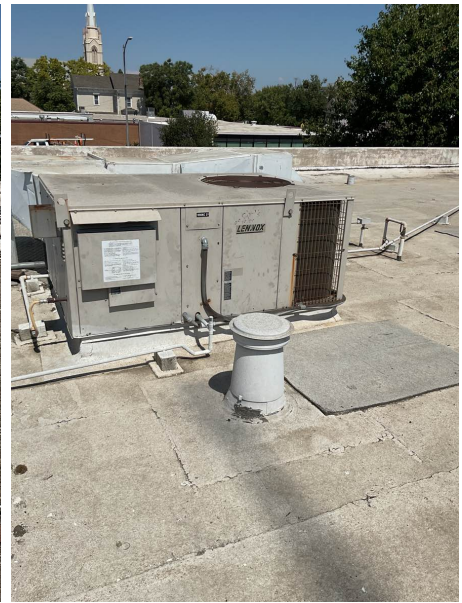
**Cooling System**

Most of the A/C units need to be replaced due to age, one of the units is abandoned.

**A/C units:** The inspector noted most units are old and one is abandoned. To ensure efficient and reliable cooling, it is recommended to have a professional HVAC technician inspect and provide a plan to replace the aging units. The abandoned unit should be properly removed.
